TO: GENERAL COMMITTEE

SUBJECT: SAM CANCELLA PARK GAZEBO REHABILITATION

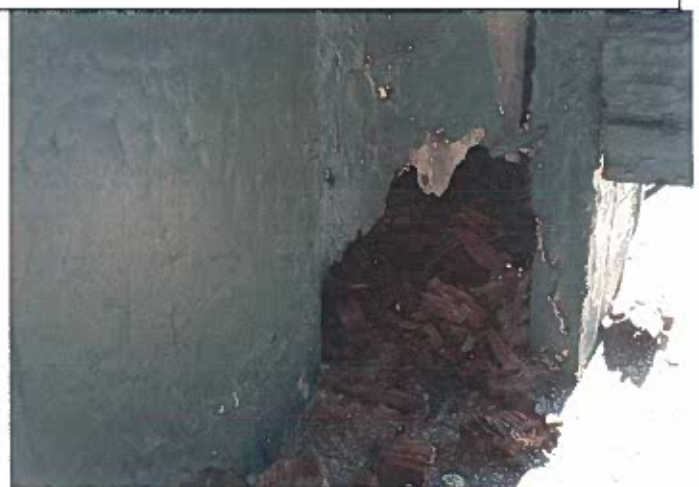
- c) All wood posts are experiencing varying degrees of wood rot, which is especially prevalent at the base. In two cases, the rot has penetrated approximately half-way up the post from the bottom; and,

Photo #4: View of base of rotted post.

- Replace all existing wood posts
- Replace two (2) structural beams
- Replace knee bracing as necessary
- Remove existing perimeter benches
- Install new perimeter guards
- Picnic tables to be installed in place of benches
- Total project cost estimated at \$40,000
