TO: GENERAL COMMITTEE

SUBJECT: MAPLEVIEW WATER TOWER ICING MITIGATION INVESTIGATION

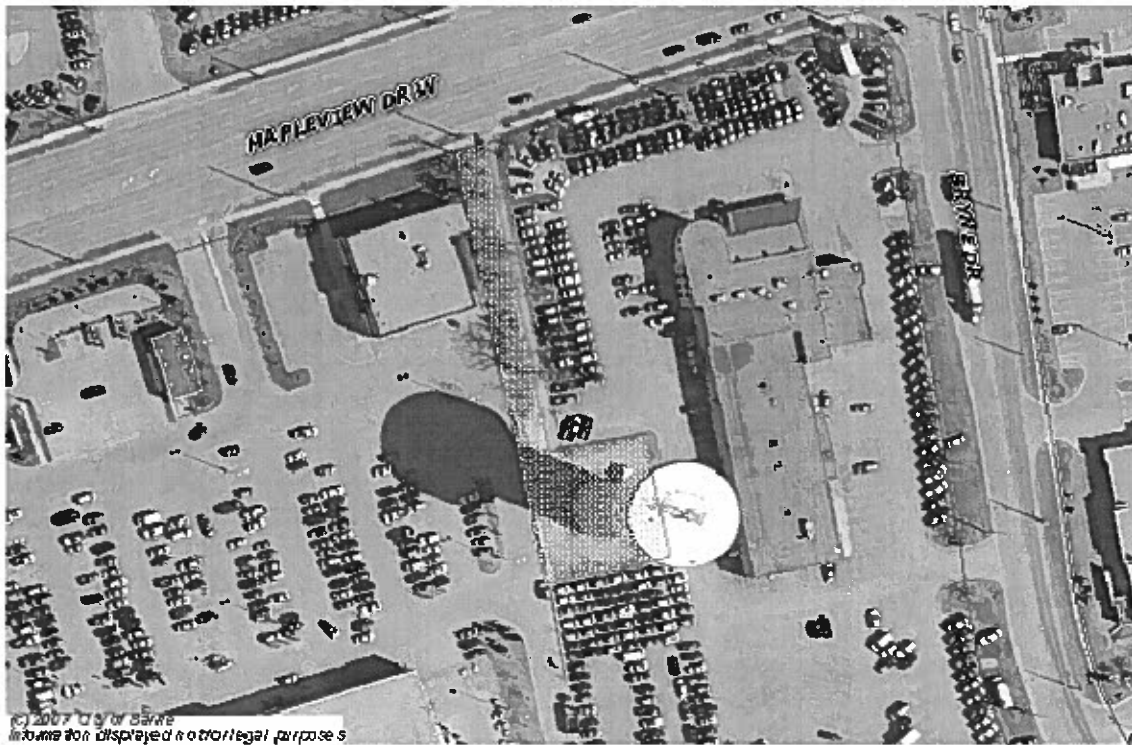
17. As can be seen below, there is limited space on the City property with the square water tower lot being approximately 30 metres x 30 metres (not including access road) and the diameter of the tower bowl being approximately 26 metres (note that due to the angle of the aerial photograph, the vertical height is askew but the tower base can be seen as being in the centre of the property).

18. The current American Water Works Standard (AWWA M42 – Steel Water Storage Tanks) states that a distance of 6.1 metres (twenty feet) should be available from the edge of the tank to the property line. This allows for any snow, icicles and rain to fall directly down onto the tower property. The 6.1 metres does not allow for wind effects on the falling ice and snow. The current distance is approximately 1.8 metres (six feet). We are unaware of why these decisions were made at that time.
