TO: GENERAL COMMITTEE

SUBJECT: INVESTIGATION TO IMPROVE TRAFFIC OPERATIONS –
INTERSECTION OF BAYVIEW DRIVE AND BALDWIN LANE

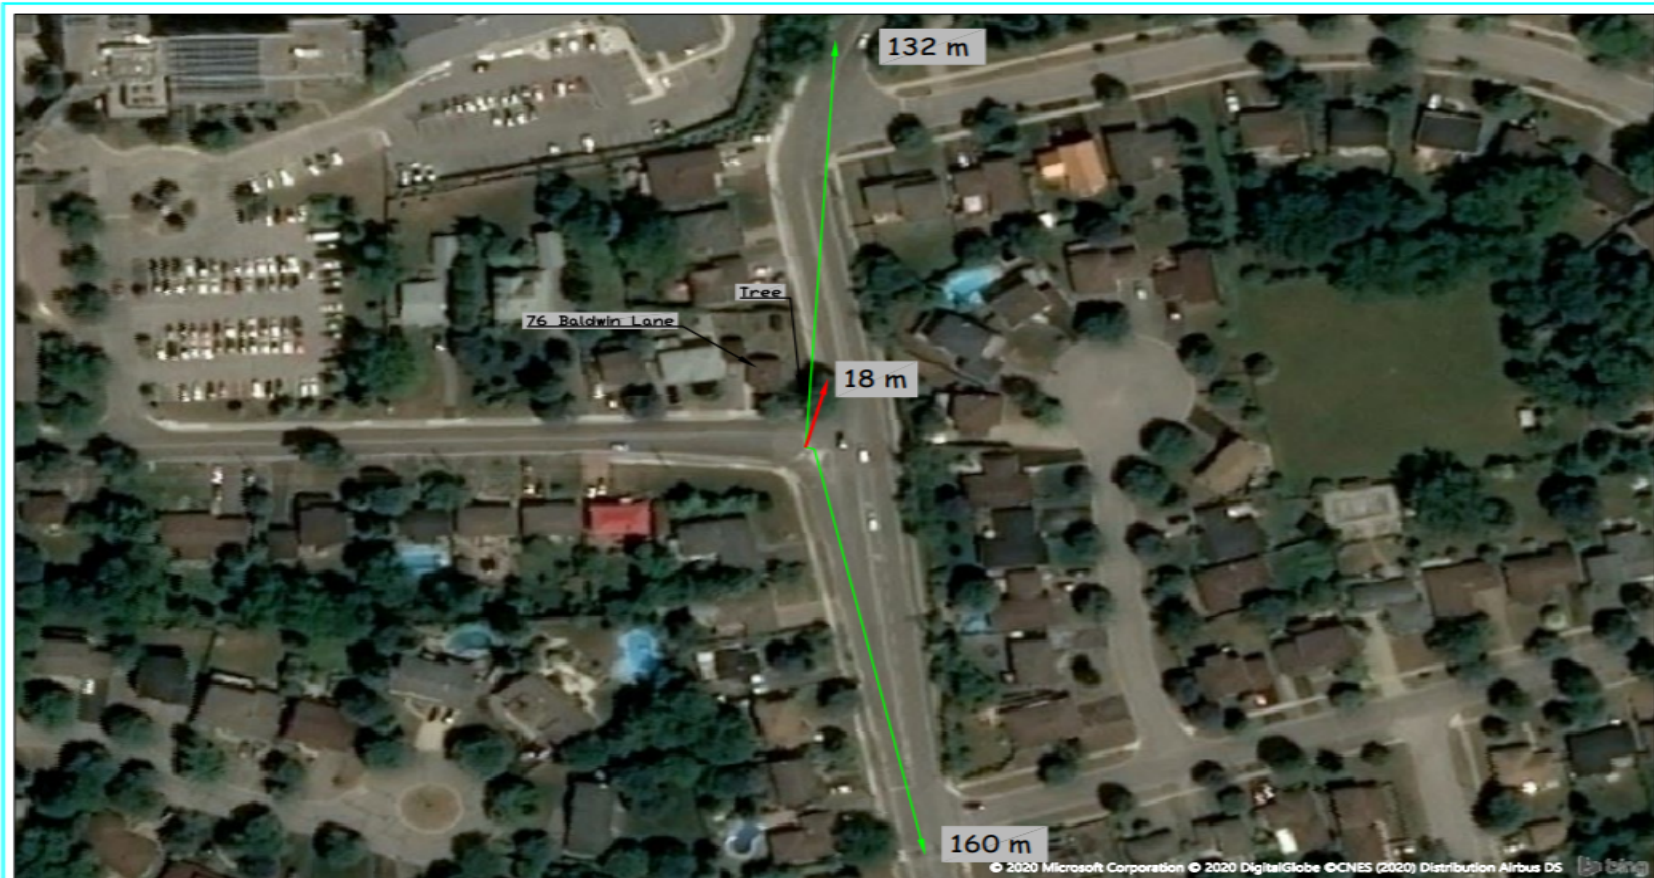
APPENDIX "A"

6. Staff received concerns regarding limited stopping sight distance for eastbound vehicles from Baldwin Lane onto Bayview Drive due to a tree located on the northwest corner of the intersection at 76 Baldwin Lane. Refer to Appendix ‘A’

10. Staff identified that the tree at 76 Baldwin Lane which is on the northwest corner of the intersection was limiting the amount of stopping sight distance for a motorist making the eastbound right turn movement onto Bayview Drive. As a result, the tree was removed which increased the visibility at the intersection. Staff completed a site visit post tree removal and measured the stopping sight distance. The measurements were 132 metres looking northbound, and 160 metres looking southbound. The minimum stopping sight distance based on Transportation Association of Canada guidelines require a minimum of 105 metres. If this minimum distance can not be achieved an all-way stop is warranted. Refer to Appendix 'A'.
