**To the Mayor and Members of Council of the City of Barrie
To Members of Heritage Barrie**

I am the owner of the property at 47 Rodney Street which is protected under the Ontario Heritage Act by Bylaw 90-323. This letter is an application to receive the Consent of Council to demolish/remove a north shed that abuts the north end of the 1849 house and the south end of the 1915 barn. It is also an application to receive the Consent of Council to allow the property to be altered by the replacement of this shed and construction of an east side porch.

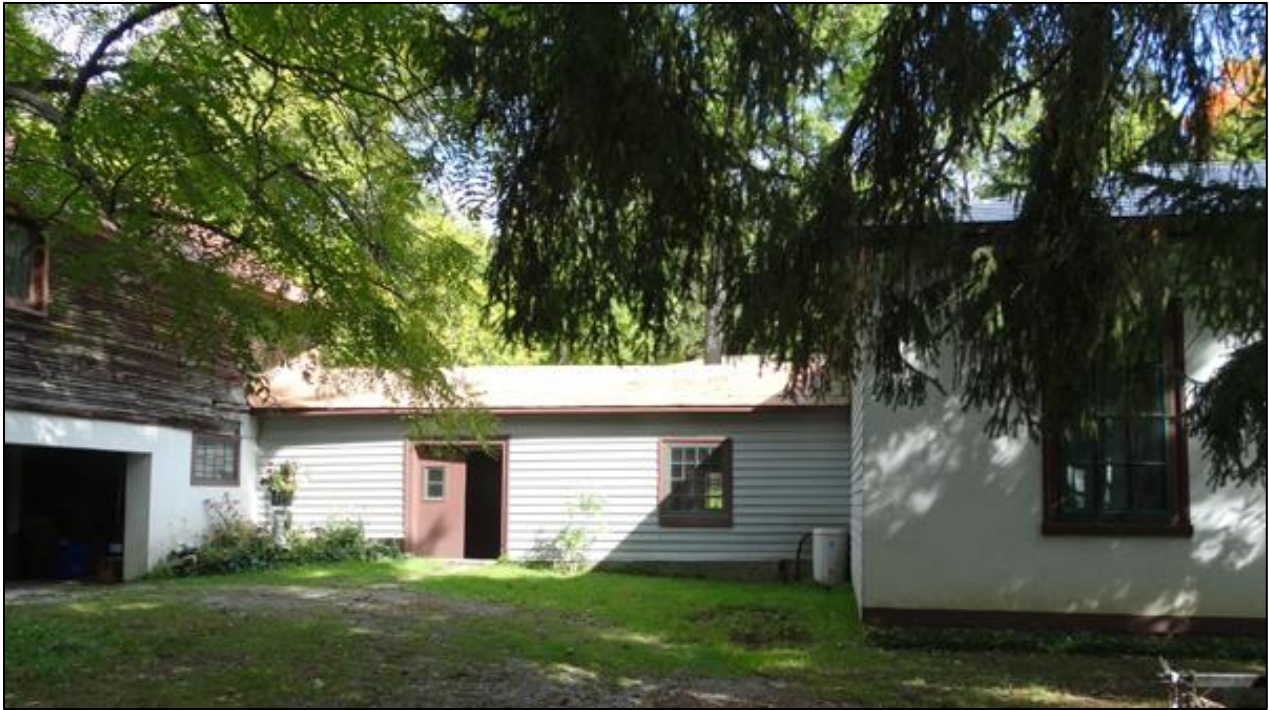
Above: West side facades. Barn is on left, abutting shed to be removed in centre, 1849 house on right. The clapboard cladding on shed was added 10 years ago to cover a section of concrete block on left and frame with asbestos board on right. The foundation is concrete slab on grade.

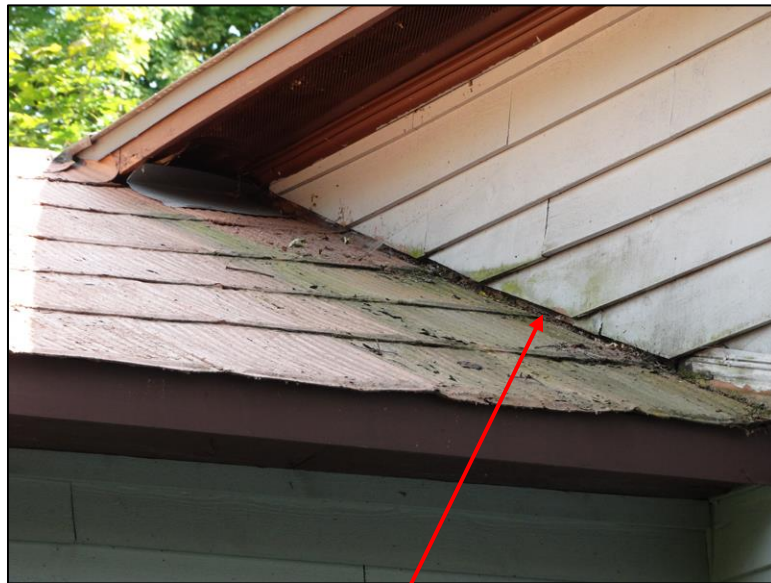
Below: Join of abutting shed and house walls at house eave. The new shed will have a slightly elongated roof pitch but will still be below the eave of house. The rusted metal roofing on the shed is about 1915.

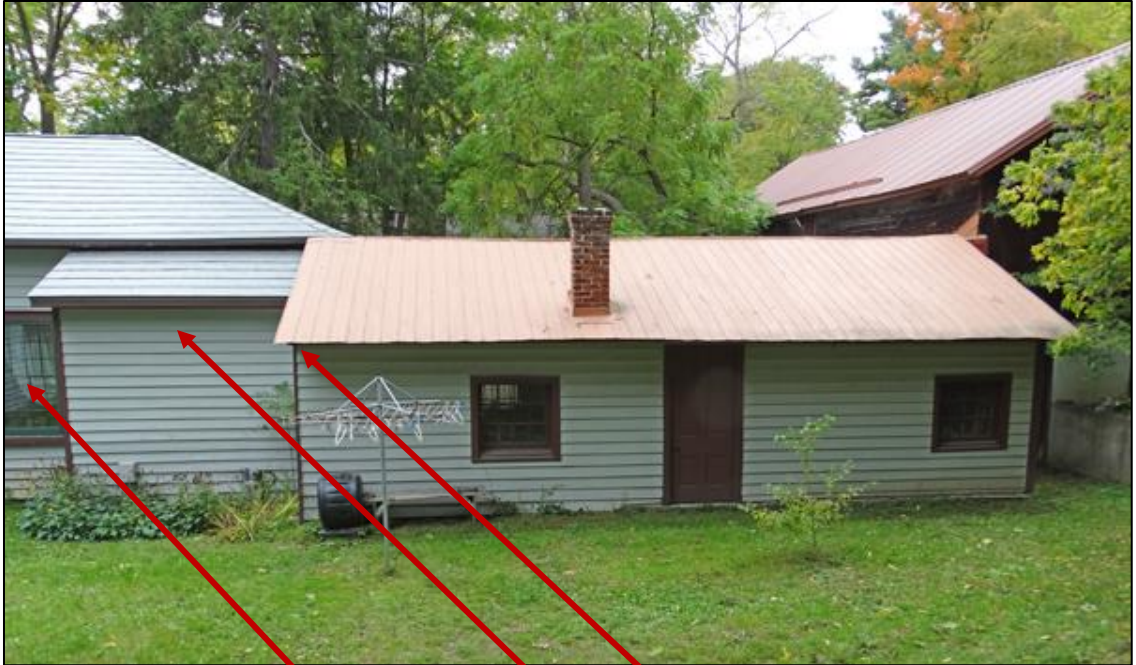
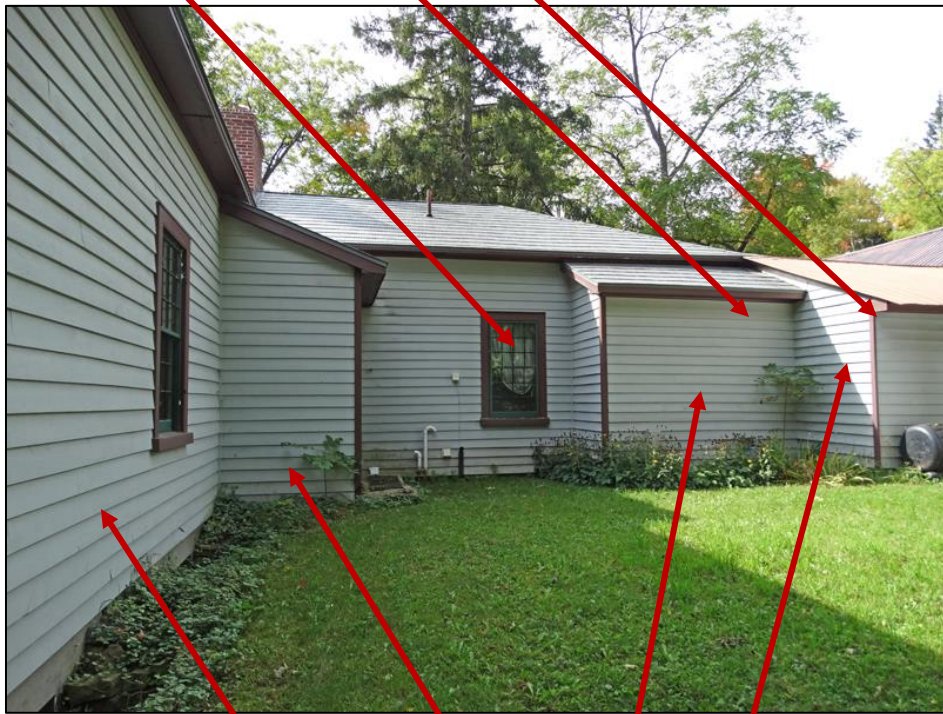
East façade showing L-R: house, 20th century enclosure of centre hall doorway, original window, 20th century enclosure of basement stairway, shed.

The replacement shed will have similar massing and appearance as existing. The 20th century enclosure of the basement stairway will be enlarged to align with the east facade of the shed. The area between the basement enclosure and the centre hall doorway enclosure will become an open porch. This is needed to push away the excessive snow accumulation in this area (as shown next page).

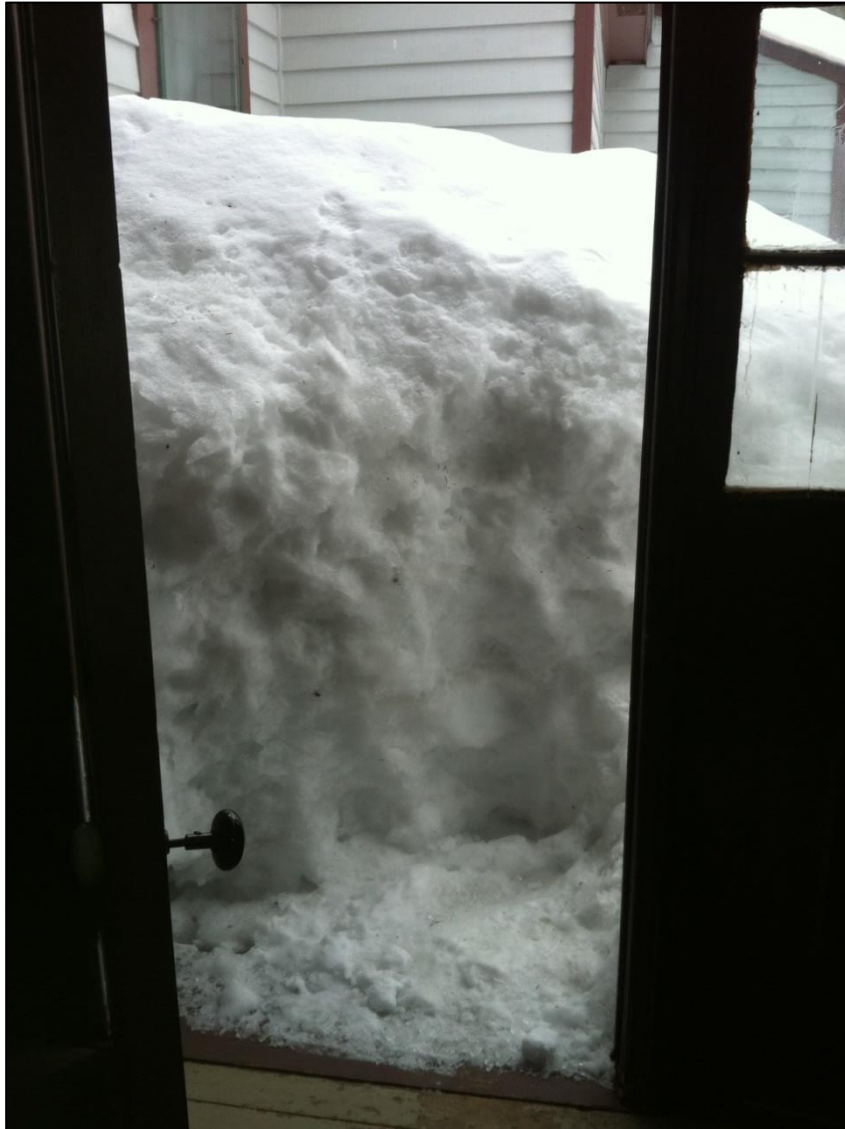
Looking north toward basement enclosure and south end of shed from inside centre doorway enclosure. Snow accumulation is due to slippery metal roof panels on the house. The snow blocks the doorway (as shown) and results in water in the basement.

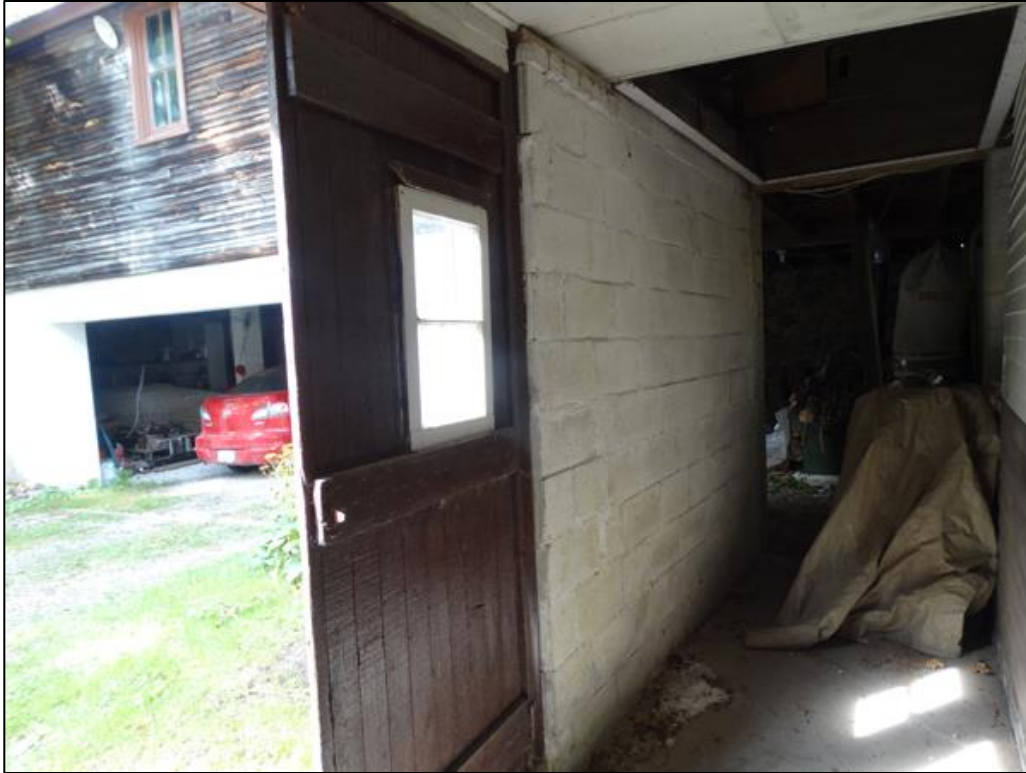
Above: Inside west side hallway of shed showing the mid 20th century concrete block wall repair on left. The double plank doors are not original to 1849.

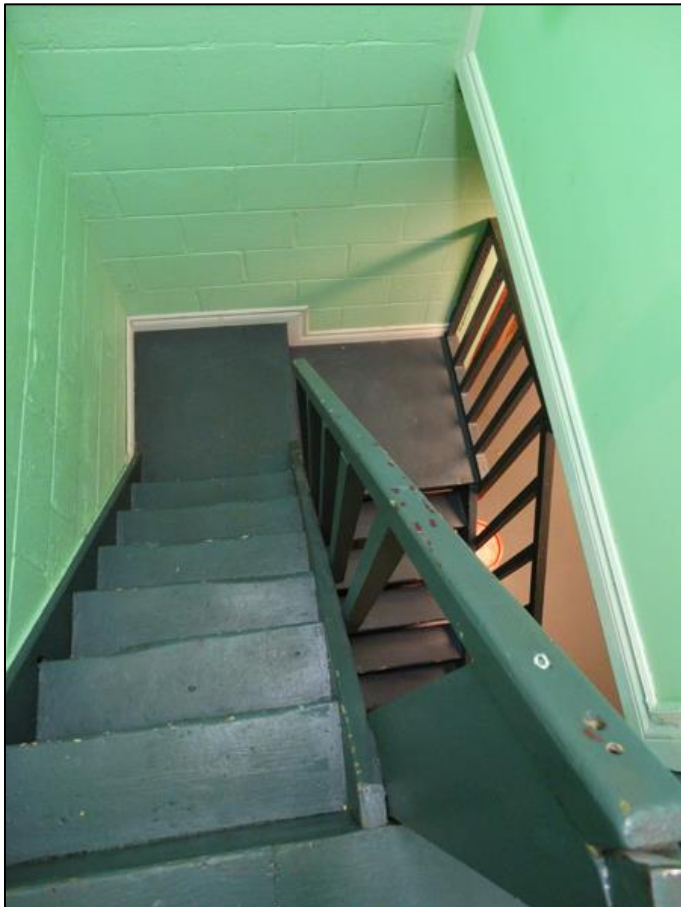
Left: Inside mid 20th century basement enclosure. This will be enlarged to allow for a stairway that meets Code.

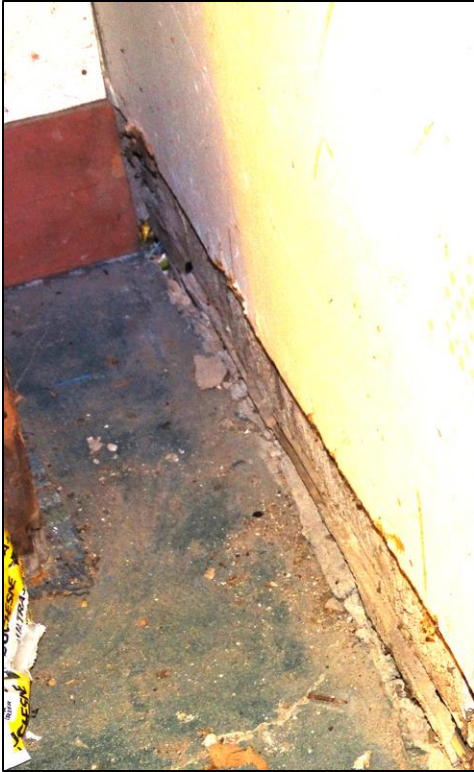
Above left: Concrete foundation slab is sinking and pulling away from shed wall where it abuts the house. Daylight is now visible starting from the east corner (as shown by arrow).

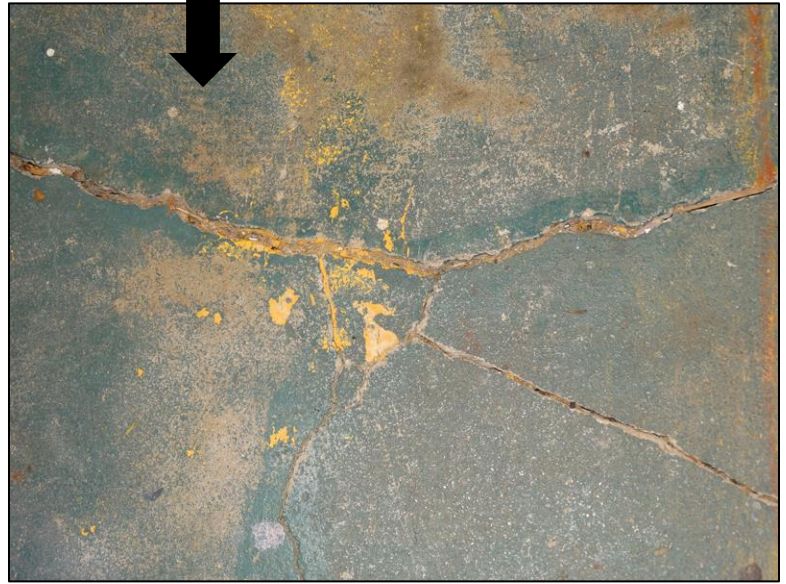
Above right: Cracks are developing as concrete foundation slab sinks.

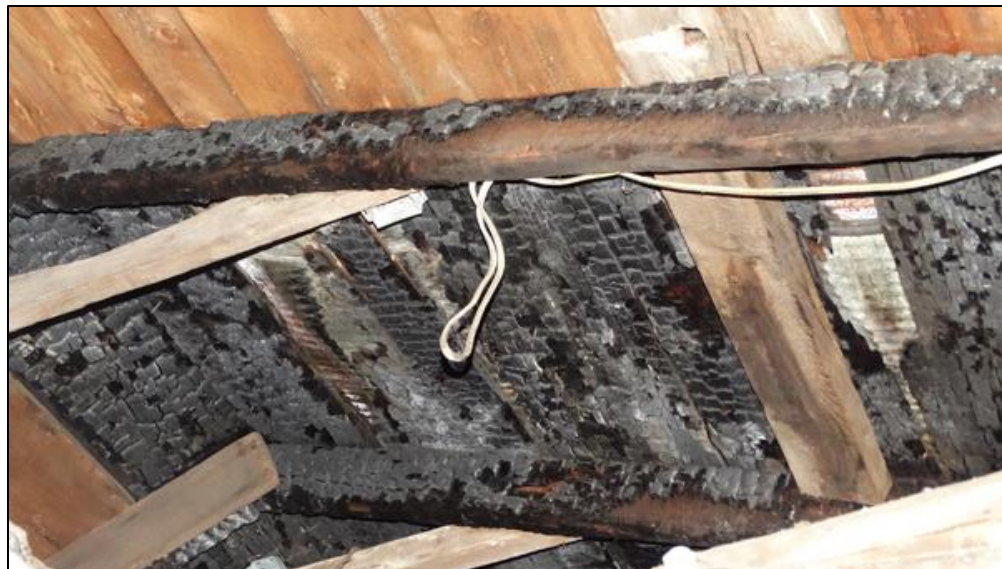
Below: Charred roofing boards and rafters with repair after 1915 barn fire. Rafter centres are about 30" (do not meet Code). Some areas of the roof are only clad by the exterior metal sheeting (no interior sheeting boards). The ceiling inside the shed leaks as a result of the deteriorating roof.
