RE: Commemoration Plan for the Property at 34-36, 38, 40, 44, & 50 Bradford Street, City of Barrie (listed under Part IV, Section 27 of the *Ontario Heritage Act*)
OUR FILE: 1350 L

RE: Masonry and Temporary Shoring Assessment
125 Dunlop Street, Barrie, ON

Photographic Log

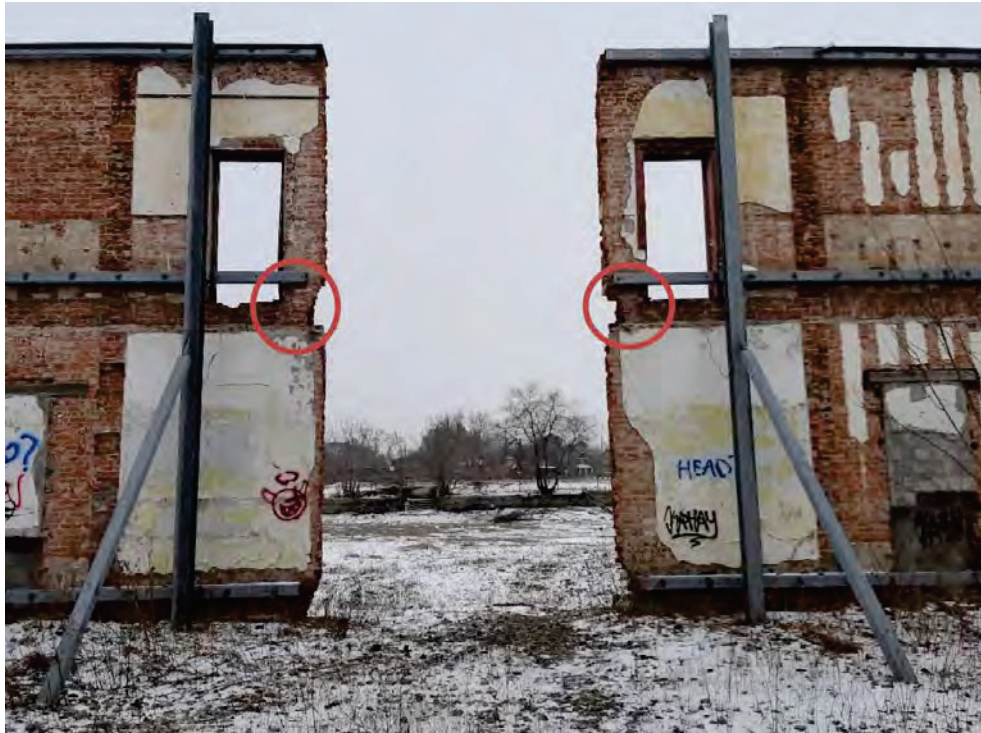
Figure 1: View of west wall opening with cracks showing under sills (source: MTE Consultants, 2024)

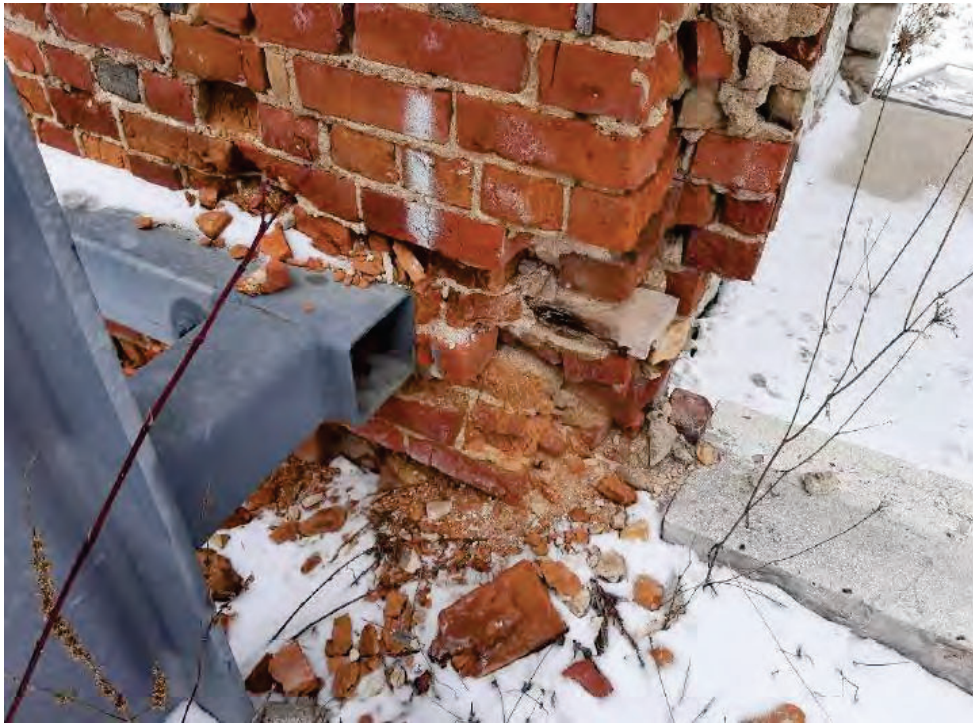
Figure 2: View of deteriorated bricks at bottom four courses of former front opening (source: MTE Consultants, 2024)

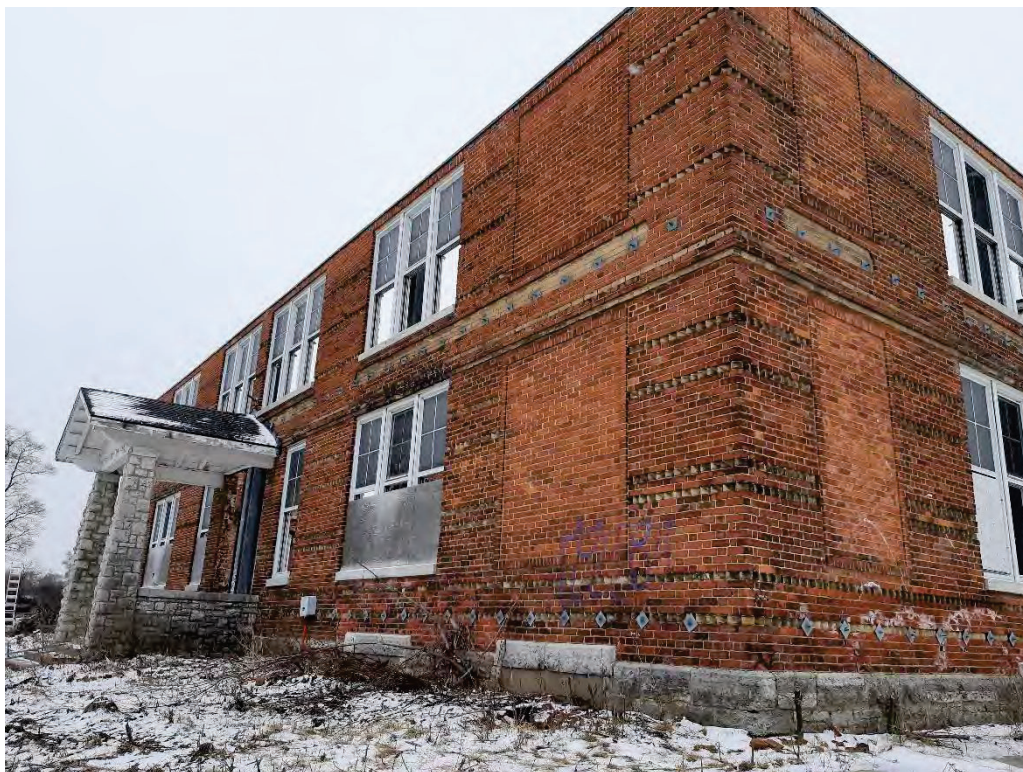
Photograph No. 1 – View of North East Corner of the Building.

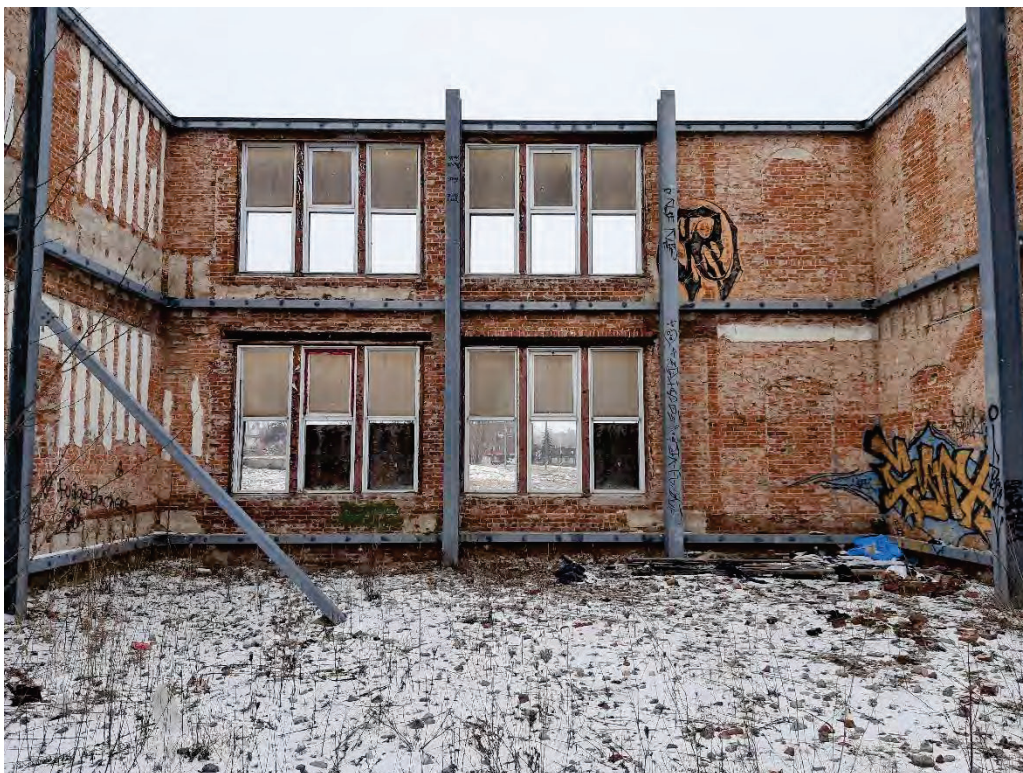
The walls are currently shored with structural steel sections supported on reinforced concrete foundations in accordance with the drawings entitled “Prince of Wales P.S. Demolition, S1.0 and S2.0” dated November 2017 prepared by MTE Consultants Inc. The shoring components remain intact and free of signs of distress. We noted that anchorage locations (through-bolts) are in good condition, free of signs of cracking or movement (refer to Photo 4). Based on our review, the temporary shoring system is performing as intended. We did not observe signs of movement or settlement.

Photograph No. 2 – Temporary structural steel shoring facing the North Elevation in the Interior.

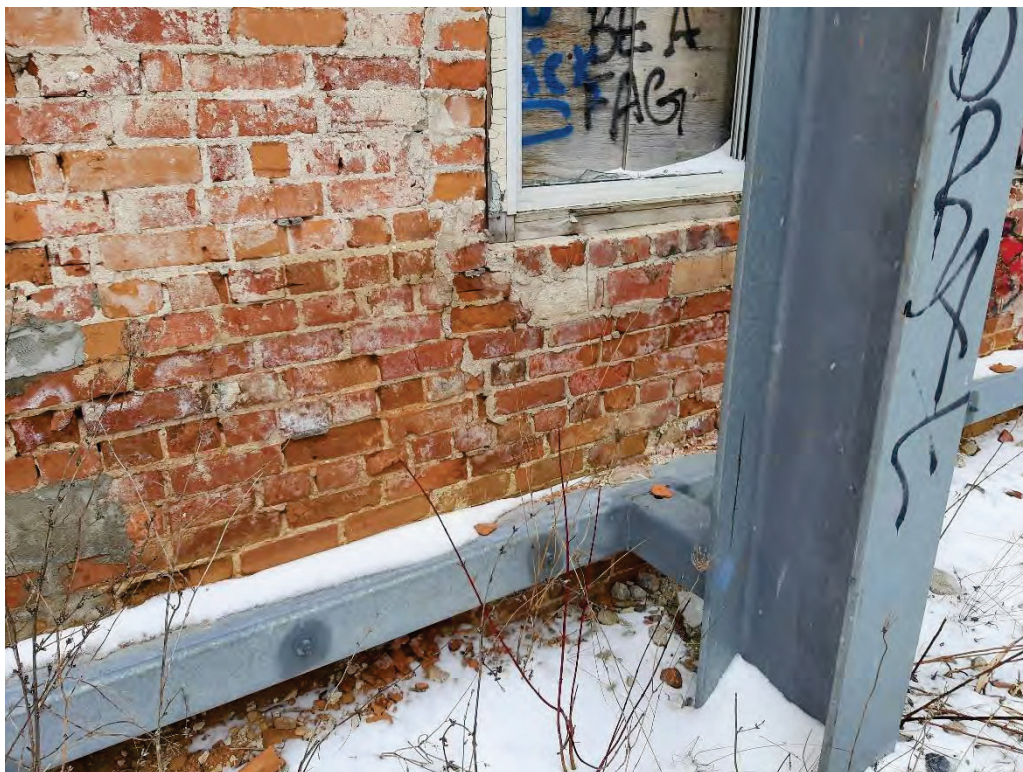
Photograph No. 3 – Interior view of the temporary shoring connection to the bottom of the wall at the interior.

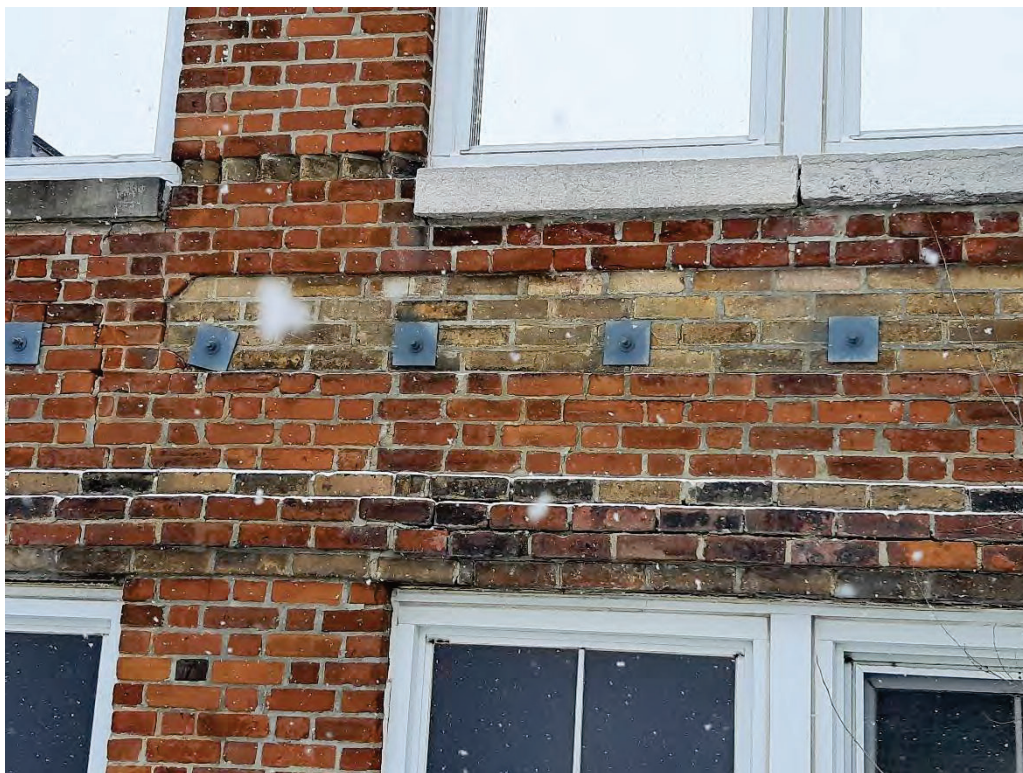
Photograph No. 4 – Through bolts at the mid height of the wall on the exterior south elevation.

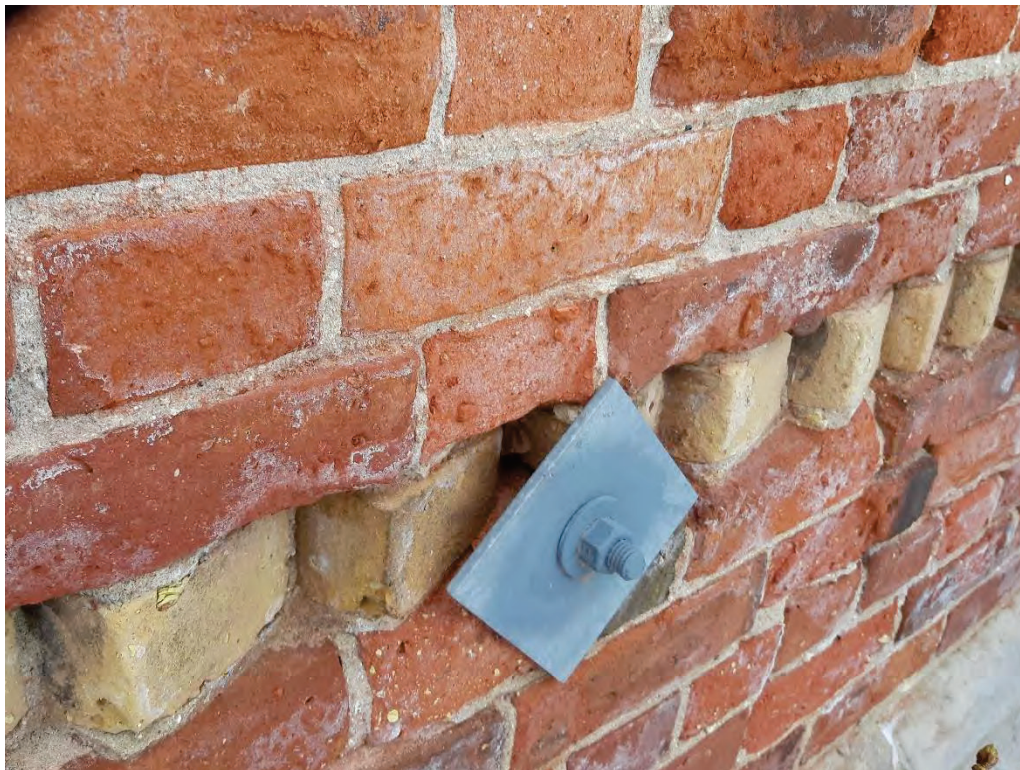
Photograph No. 5 – Close up of a through bolts.

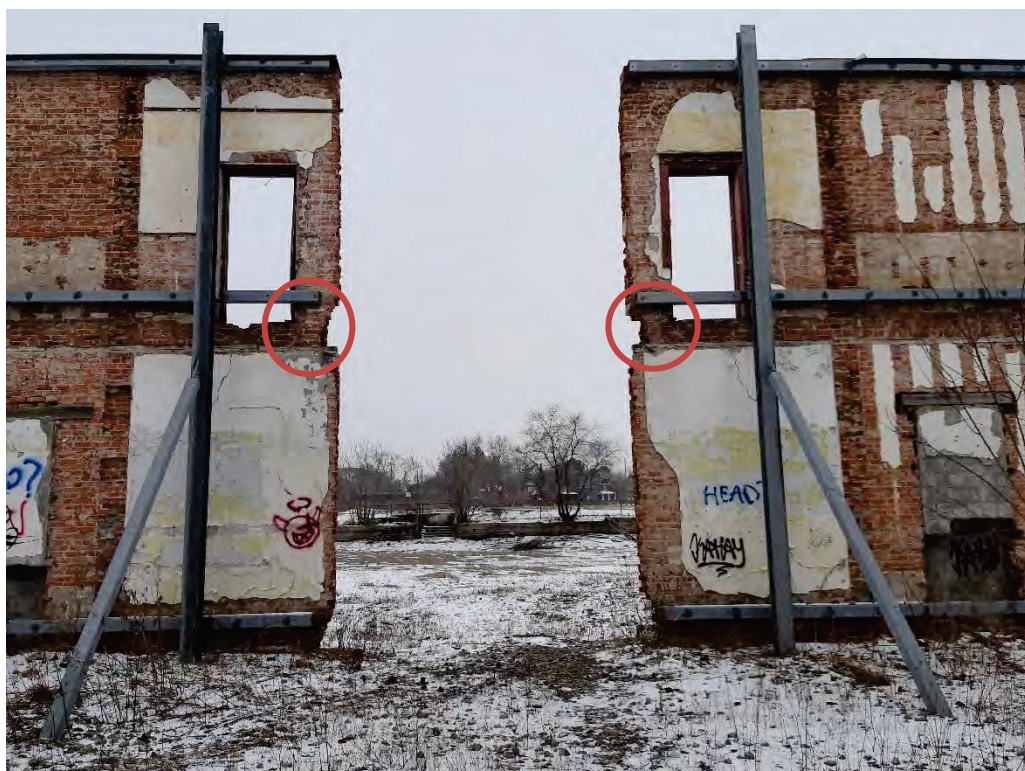
We noted that 2 of the second-floor windows are located near the end of a wall section at the middle of the west wall, resulting in small sections of brick at the bottom corner of the window, below the horizontal shoring support (refer to Photo 6). At these locations, we observed that the brick and mortar is cracking and starting to displace slightly from the wall.

Photograph No. 6 – West wall opening with cracking showing under windows at small remaining cross-section.

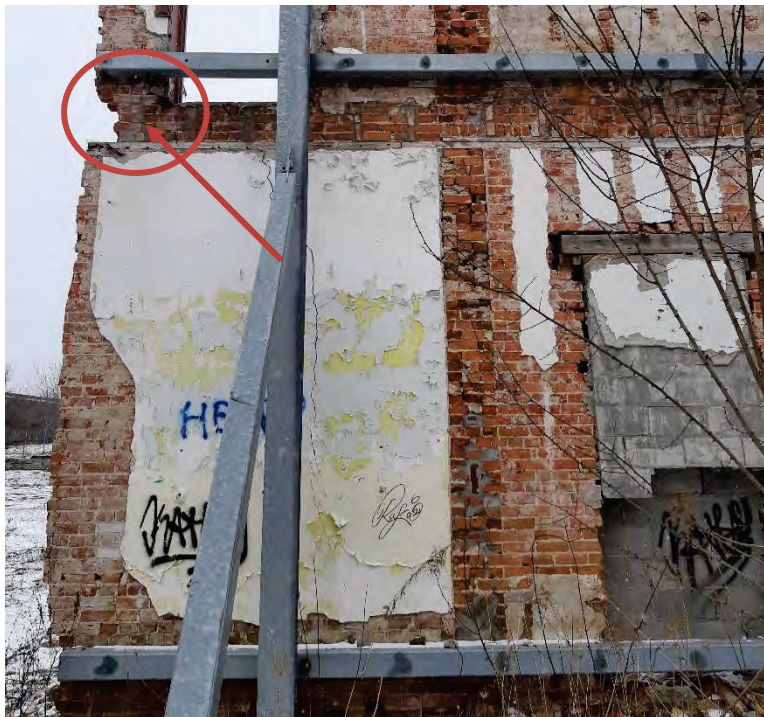
Photograph No. 7 – Cracking at the west wall below the windows.

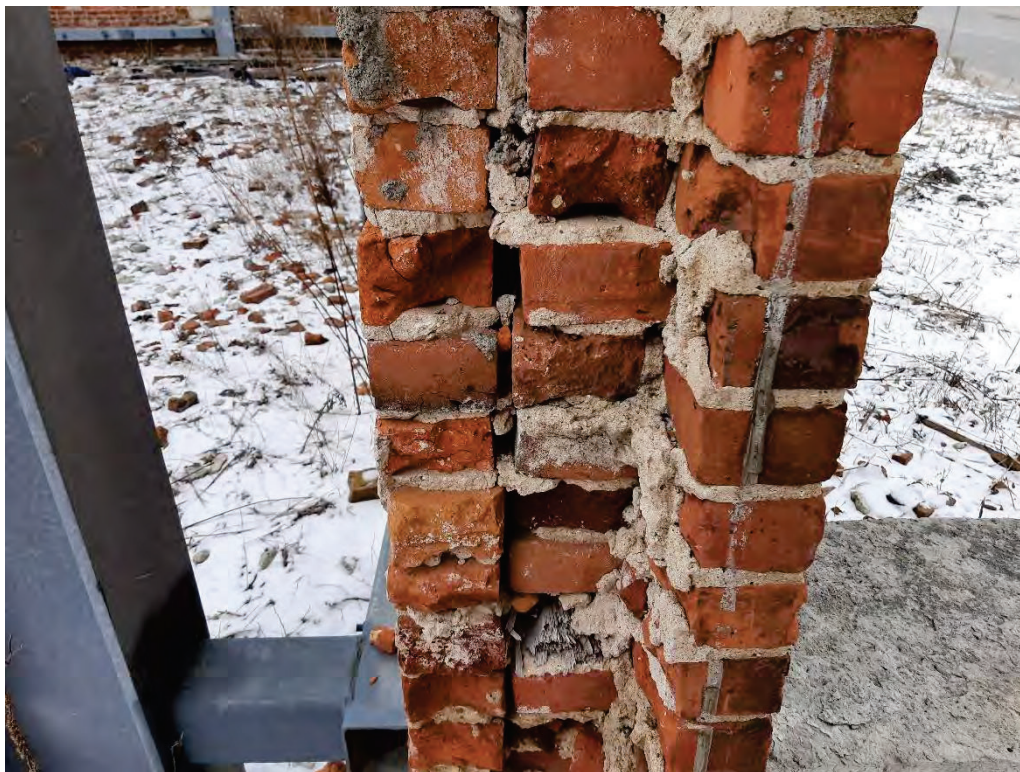
Photograph No. 8 – Cross section of the triple wythe wall.

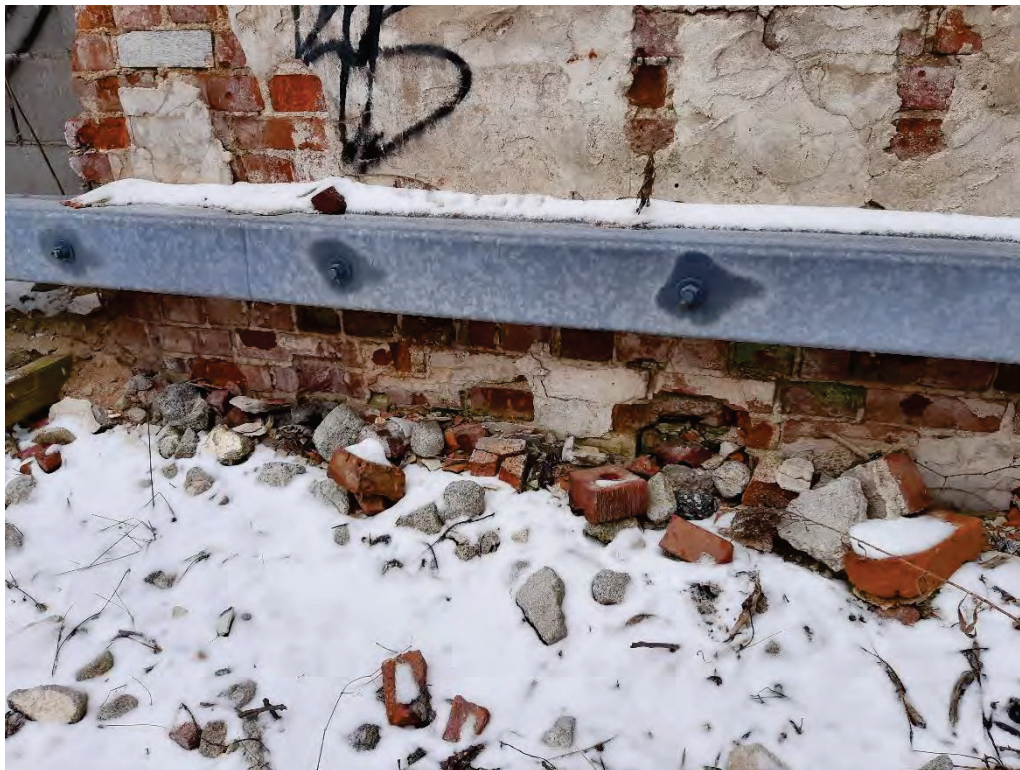
The bottom four courses of masonry have experienced the most deterioration and is spalled, cracked and soft when hit with a hammer. These courses of brick are exposed to moisture for prolonged periods of time (snow drift, splash and water-shed). Freeze-thaw cycles have weakened those bricks, and they may not hold up to foot traffic over time (refer to Photo 9). We do not recommend that the bricks from the bottom four courses be reused.

Photograph No. 9 – Deterioration of bottom four courses of bricks in the interior wythe.

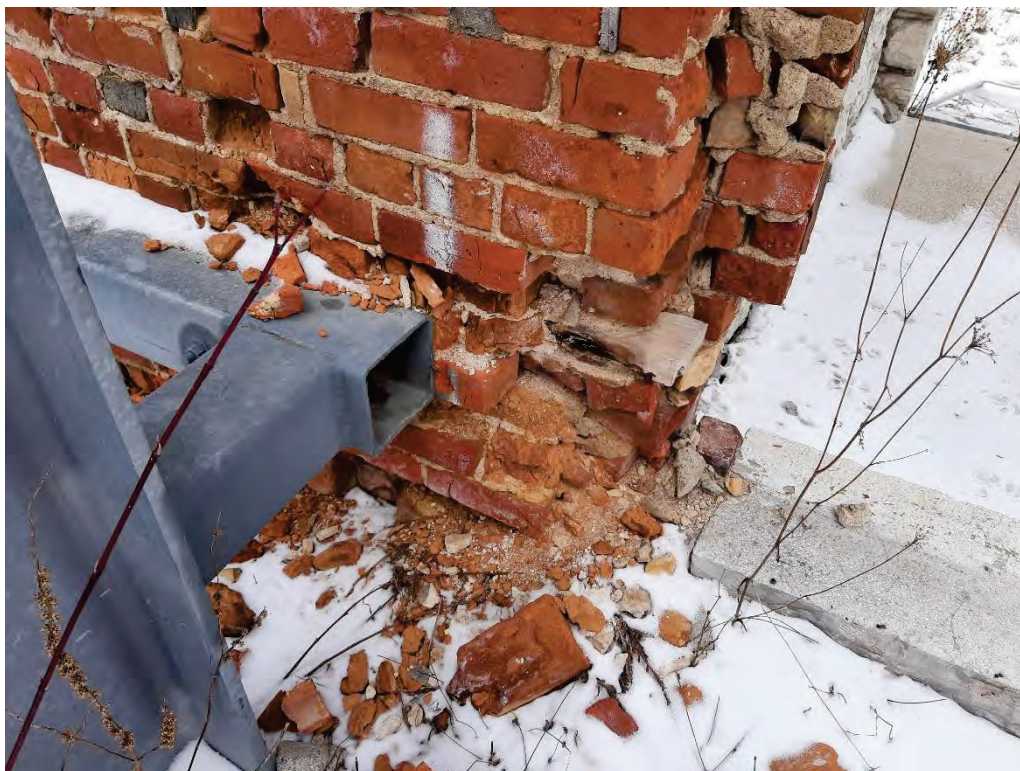
We observed that some bricks are loose at the end walls at previous door locations at grade. These bricks were observed to be in fair condition, but the mortar has failed and resulted in the bricks being loose (refer to Photo 10).

Photograph No. 10 – Deteriorated bricks at the bottom four courses at the former front opening.

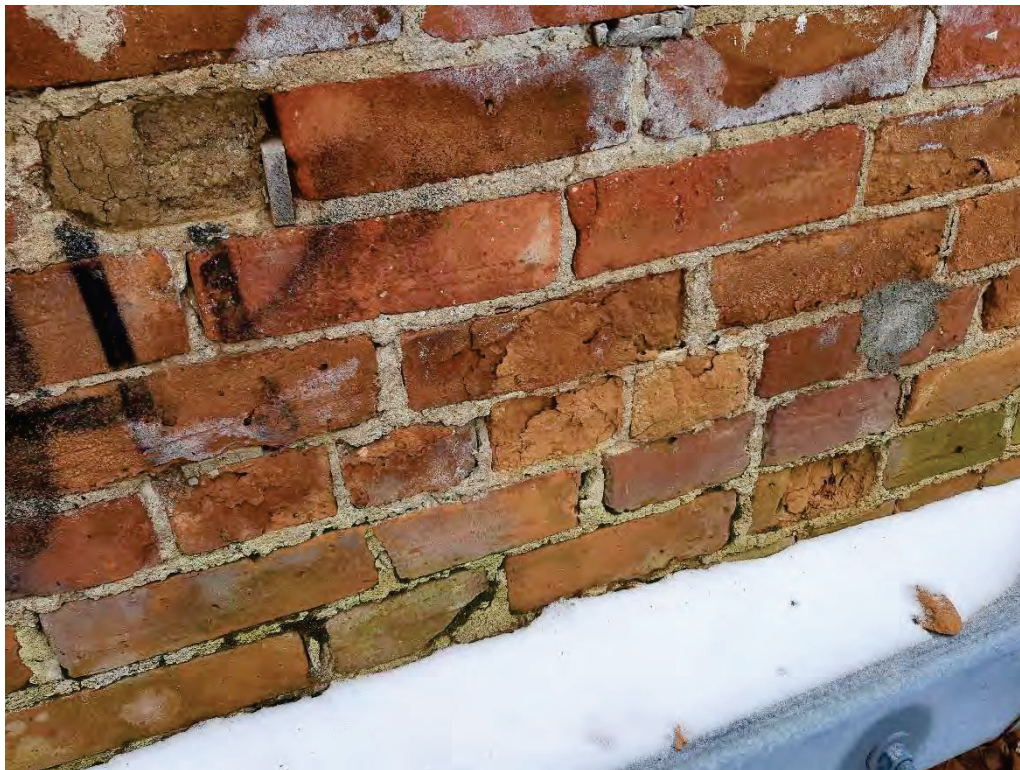
Photograph No. 11 – Isolated spalling observed on the brick surface in the interior wythe of brick.

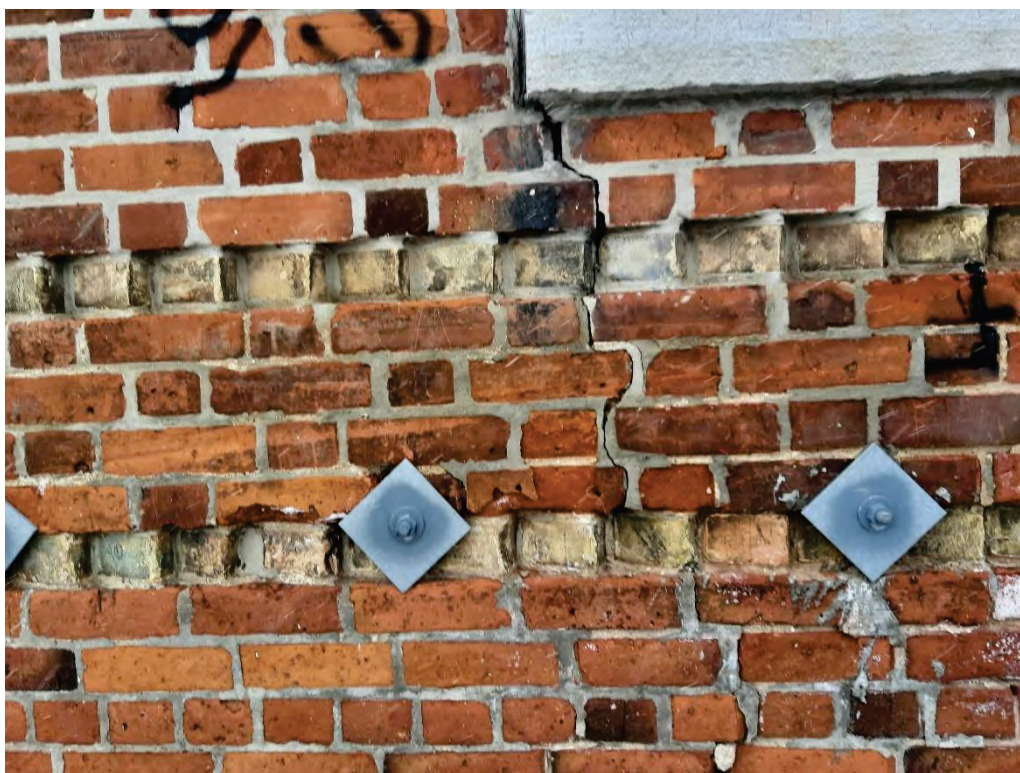
Photograph No. 12 – Some isolated step cracking noted in the brick on the exterior wythe.

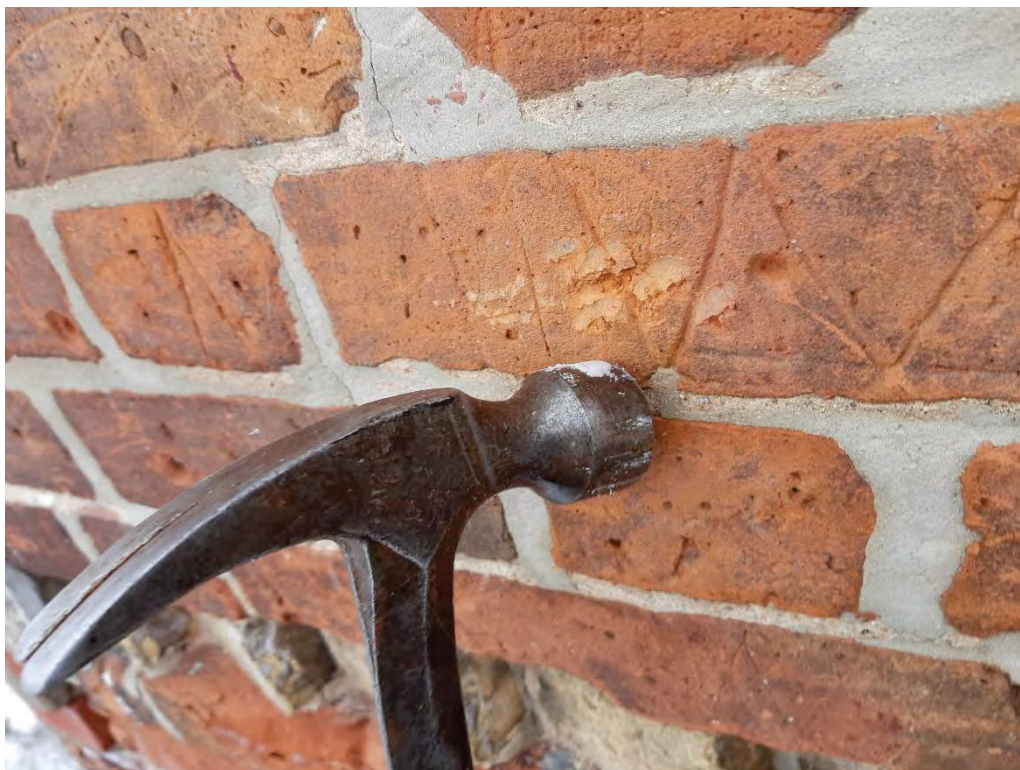
From our hammer-sounding survey, approximately 40% of the bricks were cracked, hollow-sounding, or spalled. These bricks could not be disassembled and re-assembled in a wall configuration (the bricks could not be re-laid). These bricks are suitable for use in a pathway. Some of these bricks may be re-used within Gabion basket seat walls, where the fractured segments are larger than the gaps of the baskets.

Photograph No. 13 – Hammer testing was conducted on various areas of the interior and exterior, confirming that the majority of the brick was sound. Testing was conducted with a 24 oz. Framing Hammer.

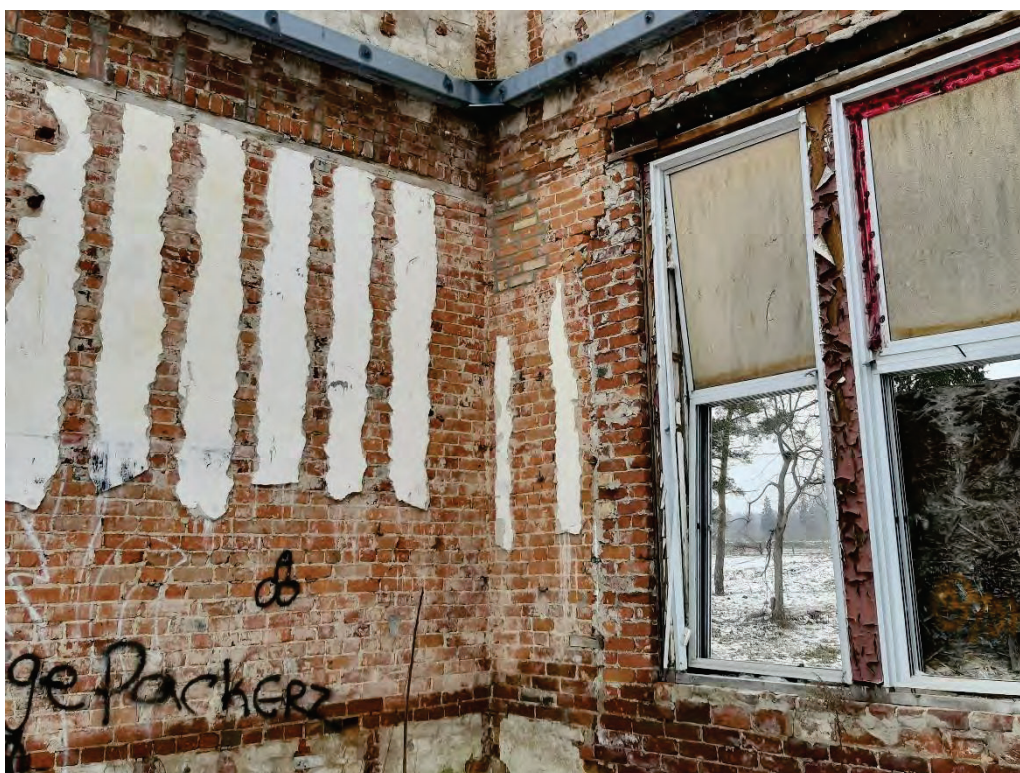
Some sections of the brick are covered in plaster or paint (refer to Photo 14 & 15). At locations adjacent to the plaster (where the plaster had been removed), the exposed bricks are intact, and the face was not compromised by the plaster removal operations. As such, we anticipate that most of the bricks can be re-purposed once the plaster is removed, but we have accounted for 15% of the bricks to be damaged by removal procedures to be conservative, given the proposed use of the materials.

Photograph No. 14 – Some plaster on brick in the interior elevation remains. It appears that the removal process did not impact the face of the brick.

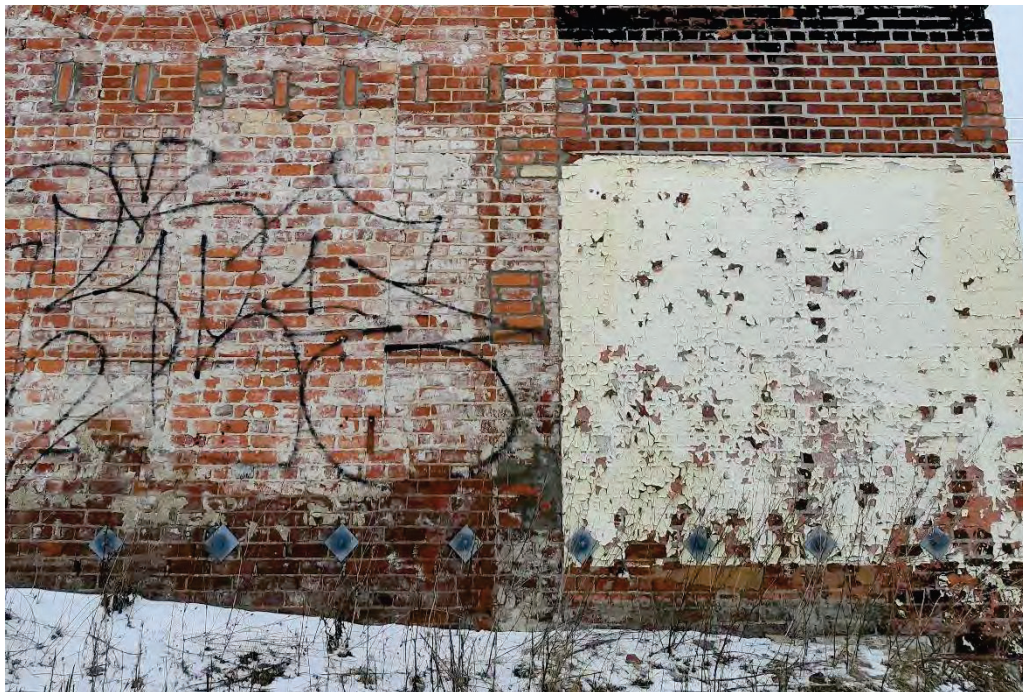
Photograph No. 15 – Paint on the brick on the exterior of the west elevation.
